Groundwater Monitoring Program

Proposed Industrial Subdivision
Stage 3, Lot 210 D.P.1174939, 2 Westrac Drive, Tomago

Prepared for
Northbank Enterprise Hub Pty Ltd

Project 39920.09
April 2025

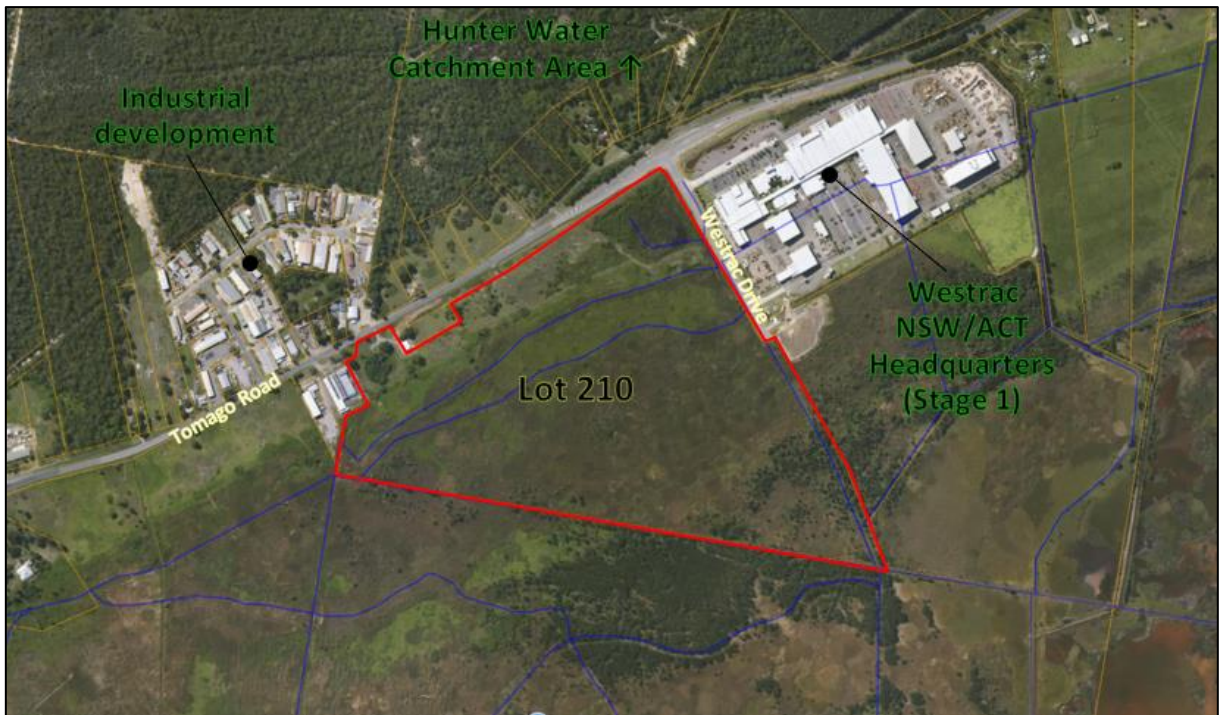
Figure 1: Approximate Lot 210 / Stage 3 boundary shown in red (Base Image source: MetroMap 2023)

The Stage 3 site details are summarised below and shown on Figure 1 and 2 below and on Drawing 1 in Appendix D.

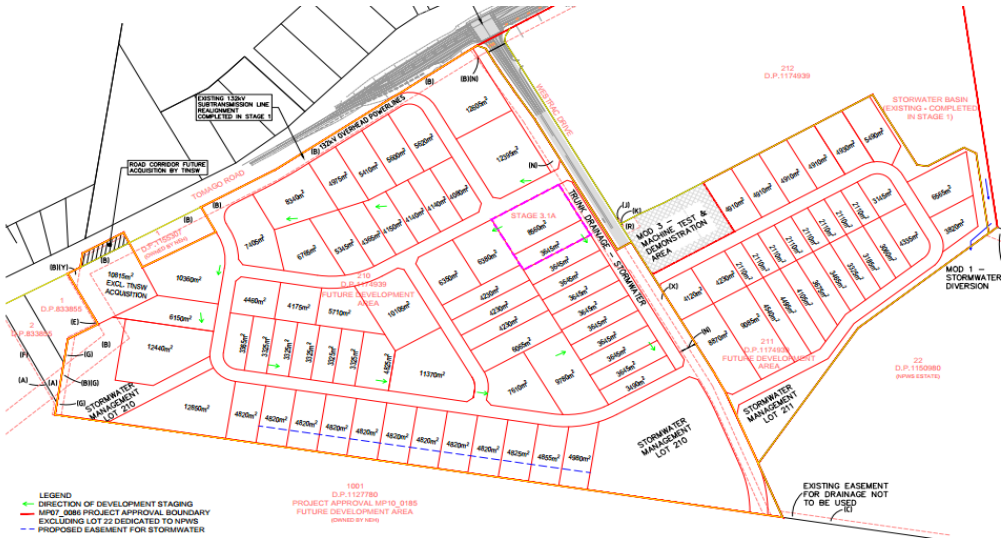
TARP #2 describes the adopted triggers, proposed actions and responses to identify and mitigate the potential impacts of the Project on the drinking water supply (Hunter Water Corporation) due to changes in groundwater quantity in the Tomago Sandbeds.																									
		Commitments and monitoring																									
		<p>1) The following will be undertaken prior to the commencement of Stage 3 works:</p> <ul style="list-style-type: none">- Installation of live water level monitoring device at MW101 and SK3520 (refer to Figure 5 on Page 8 for monitoring locations).- Assessment of baseline conditions at MW101 screened in the Tomago Sandbeds and located near the upstream boundary of the site.- Collection and review of monitoring data collected at the HWC bore (SK3520) screened in the Tomago Sandbeds and located about 1 km northeast of the project to assess baseline conditions at this location. <p>2) The following will be undertaken during the first 3 months from the commencement of Stage 3 works:</p> <ul style="list-style-type: none">- Continued monitoring and assessment of water level data at MW101 and SK3520 to establish baseline water level trends. <p>3) The following will be assessed and reported to NPWS every 6 months from the commencement of Stage 3 works:</p> <ul style="list-style-type: none">- Review of water level monitoring results at both MW101 and SK3520. <p>MW101 and SK3520 are both screened in the Tomago Sandbeds. The purpose of monitoring both MW101 located within the site and SK3520 located outside of the site is to assess whether any observed trends are attributable to the project or to regional stressors.</p>																									
Estate Layout Plan		TARP

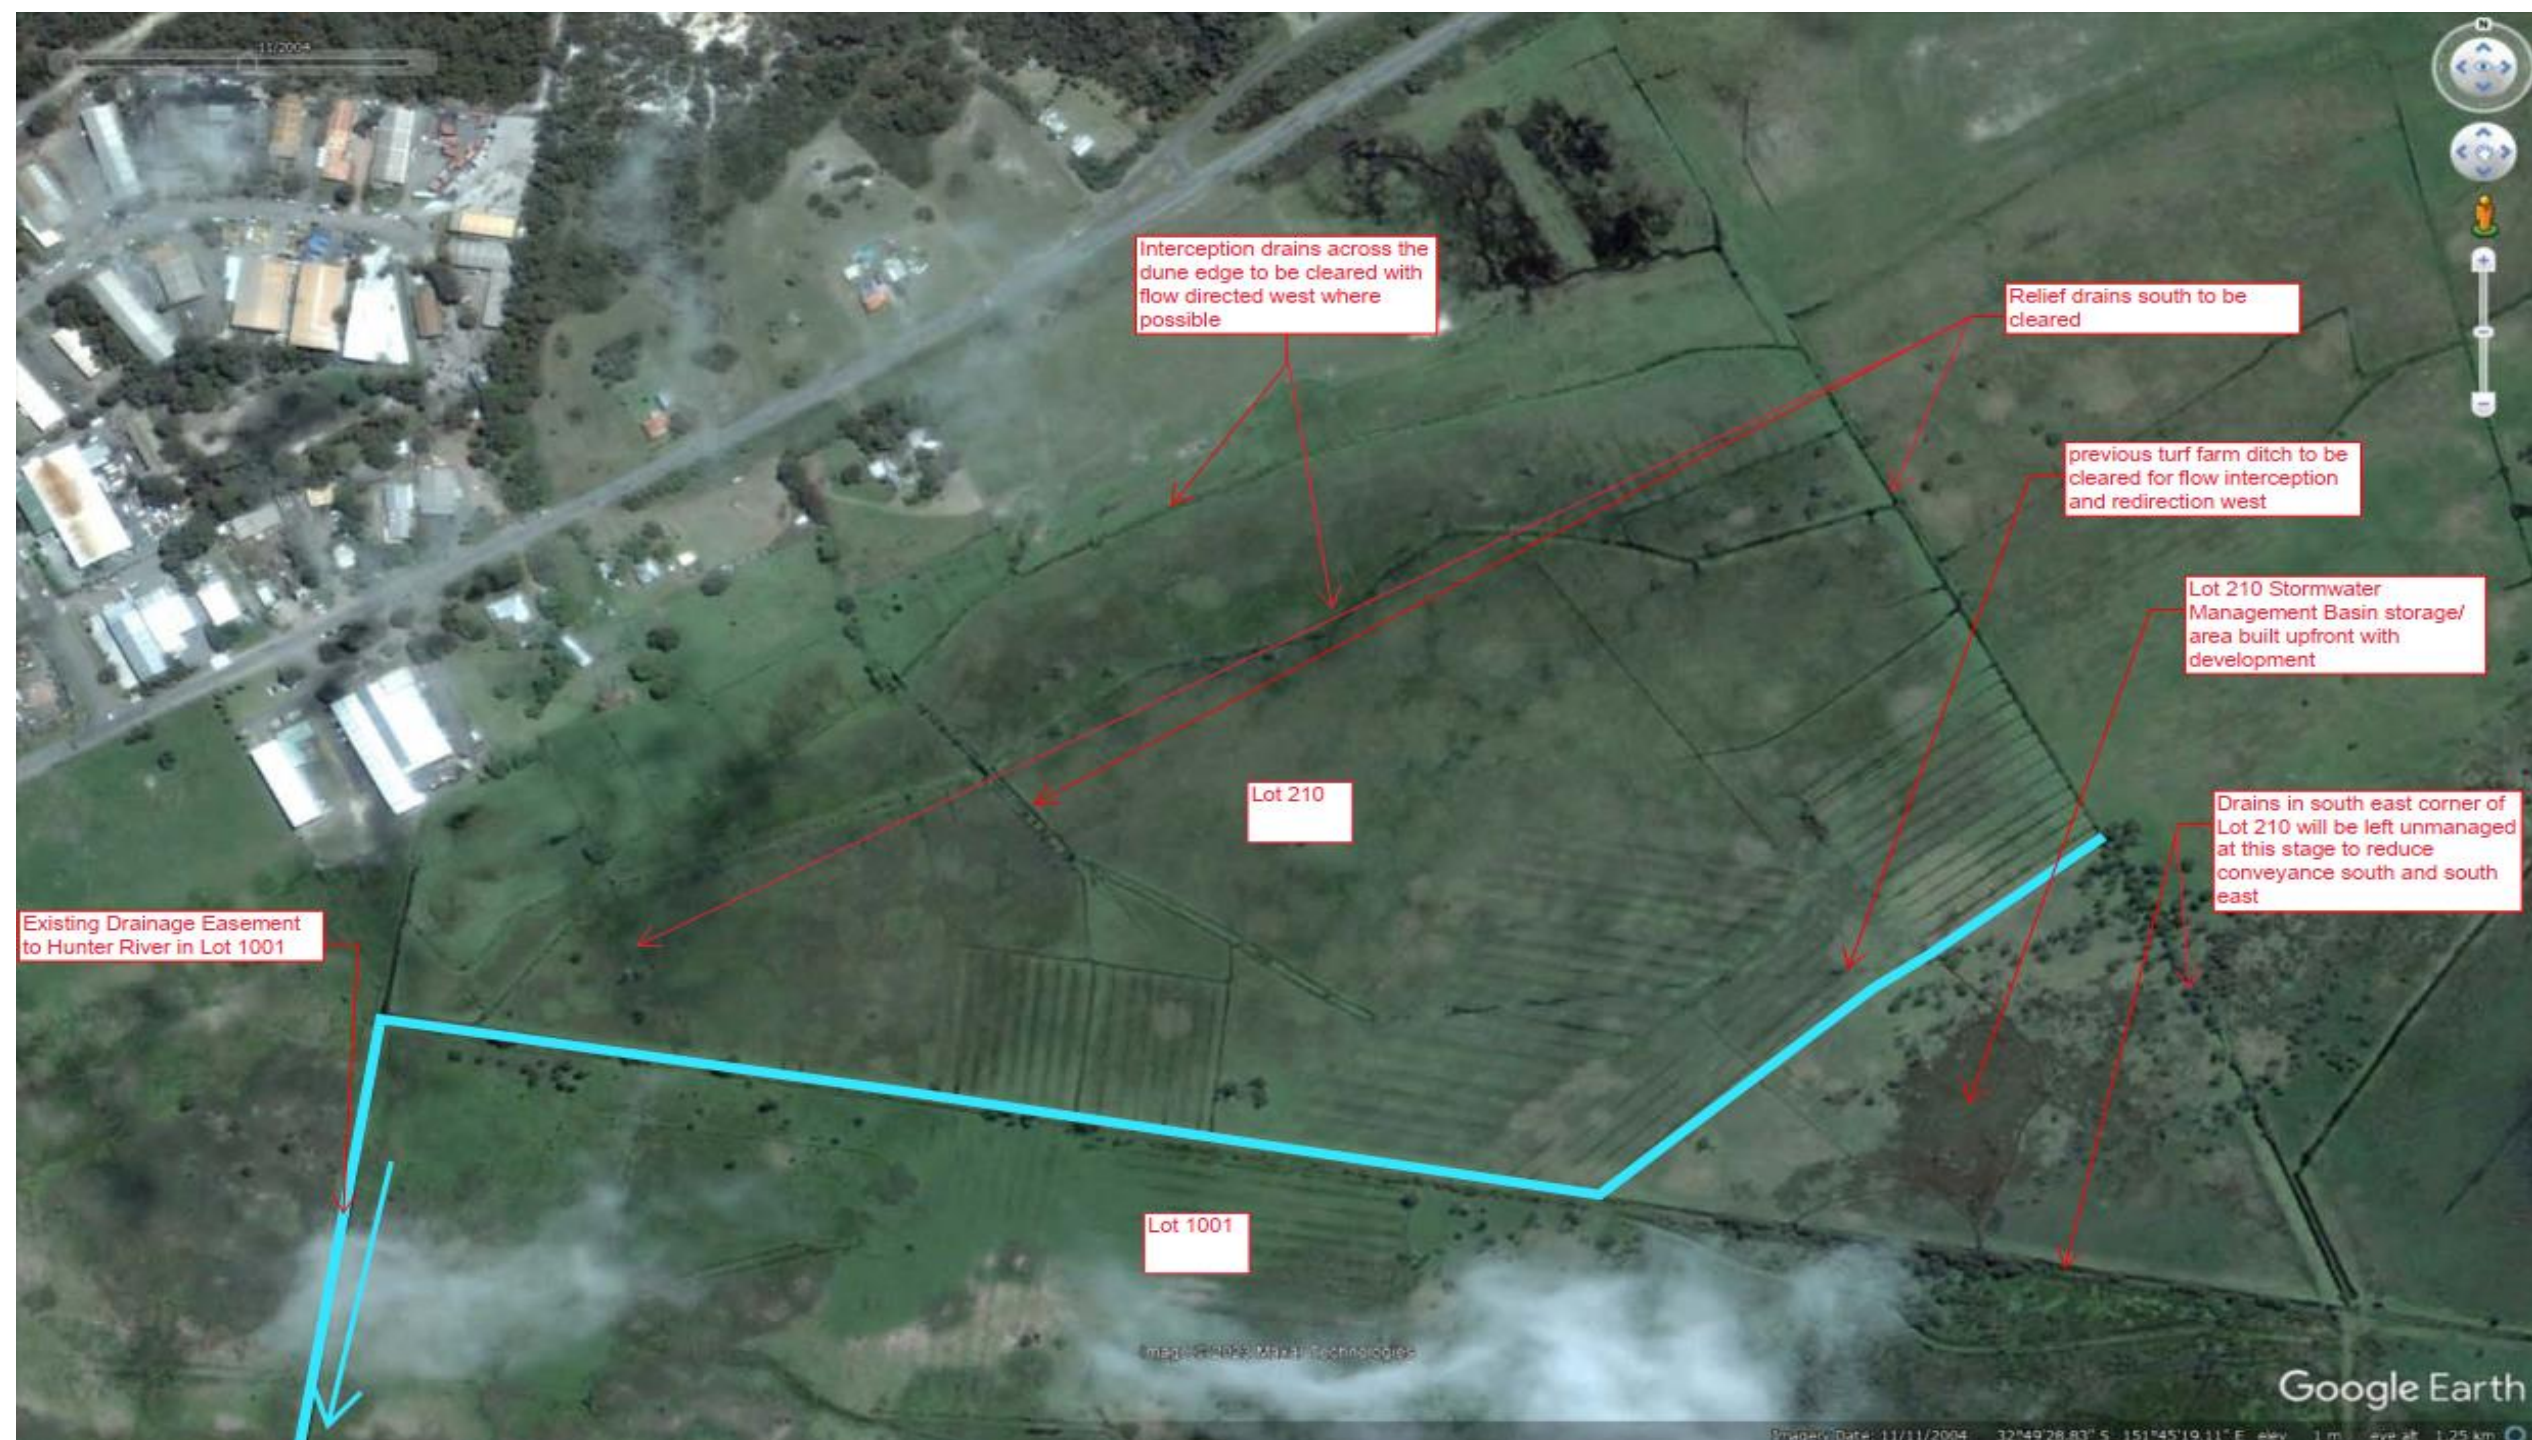
Figure 2: Response 1 (for TARP#1 on Page 1) - Capping of the existing culvert at the southeastern corner of Lot 210

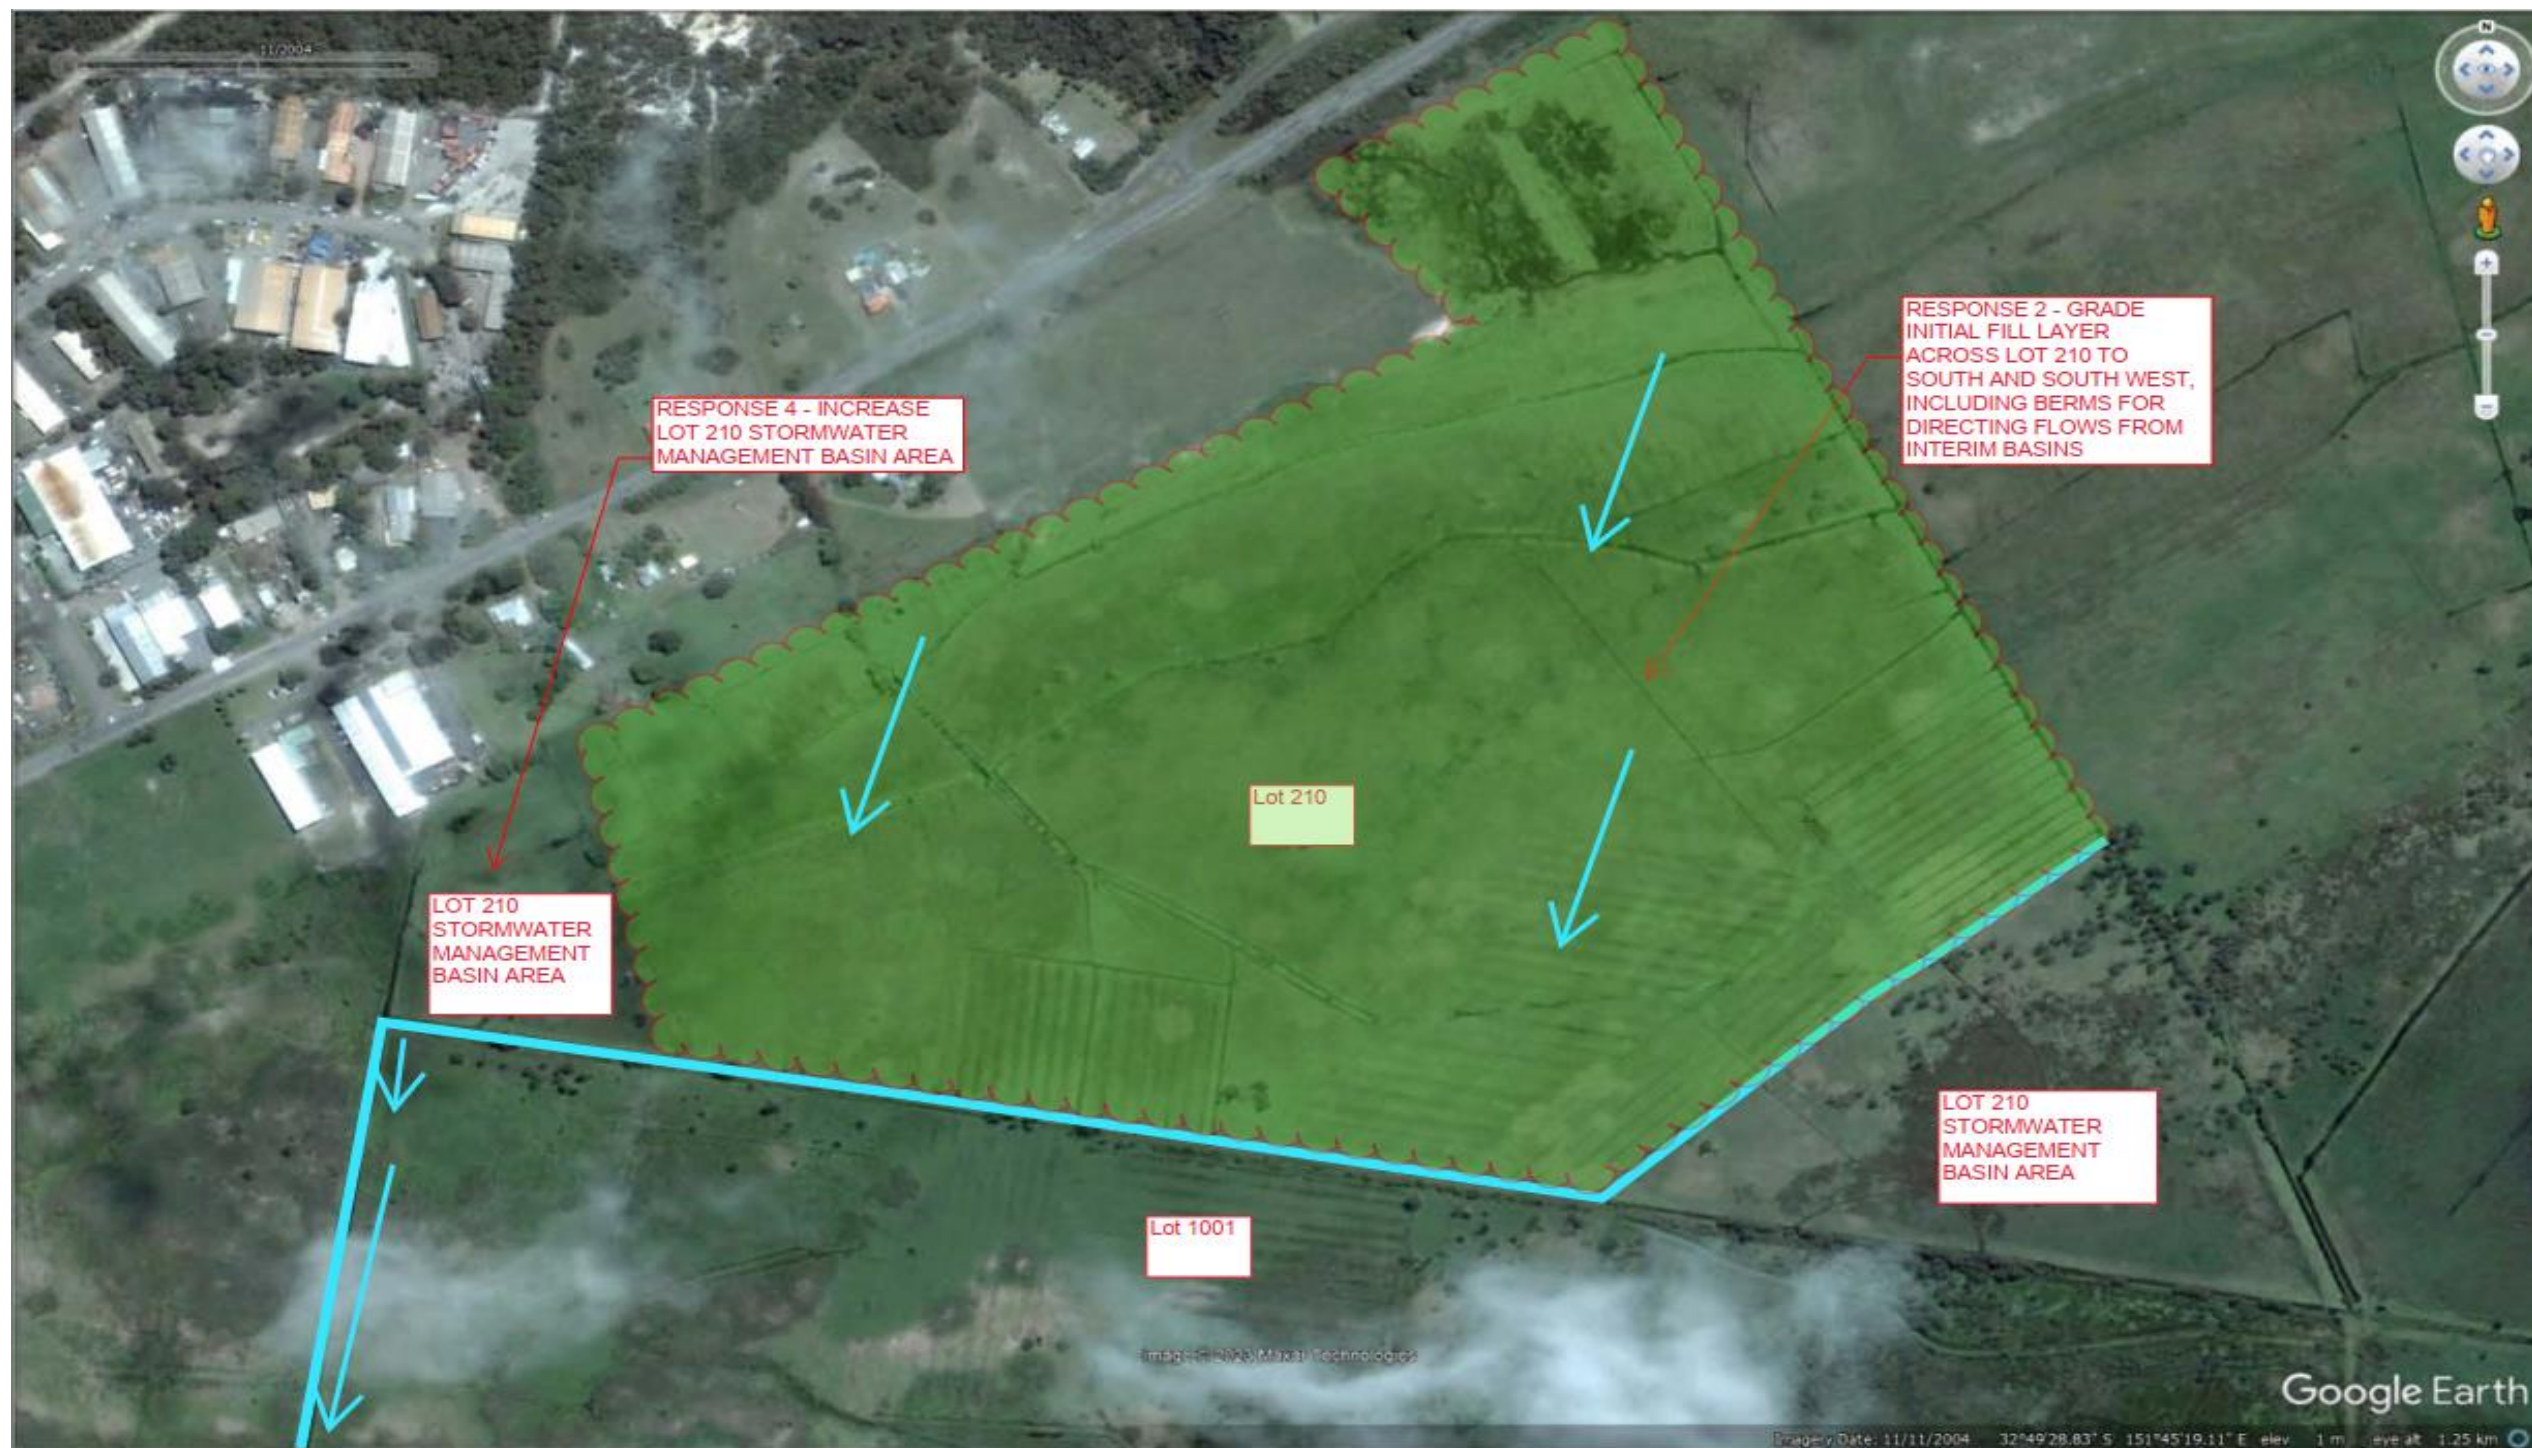
Figure 4: Response 3 (for TARP#1 on Page 1) - Additional drain clearing along the existing drainage easement at Lot 1001

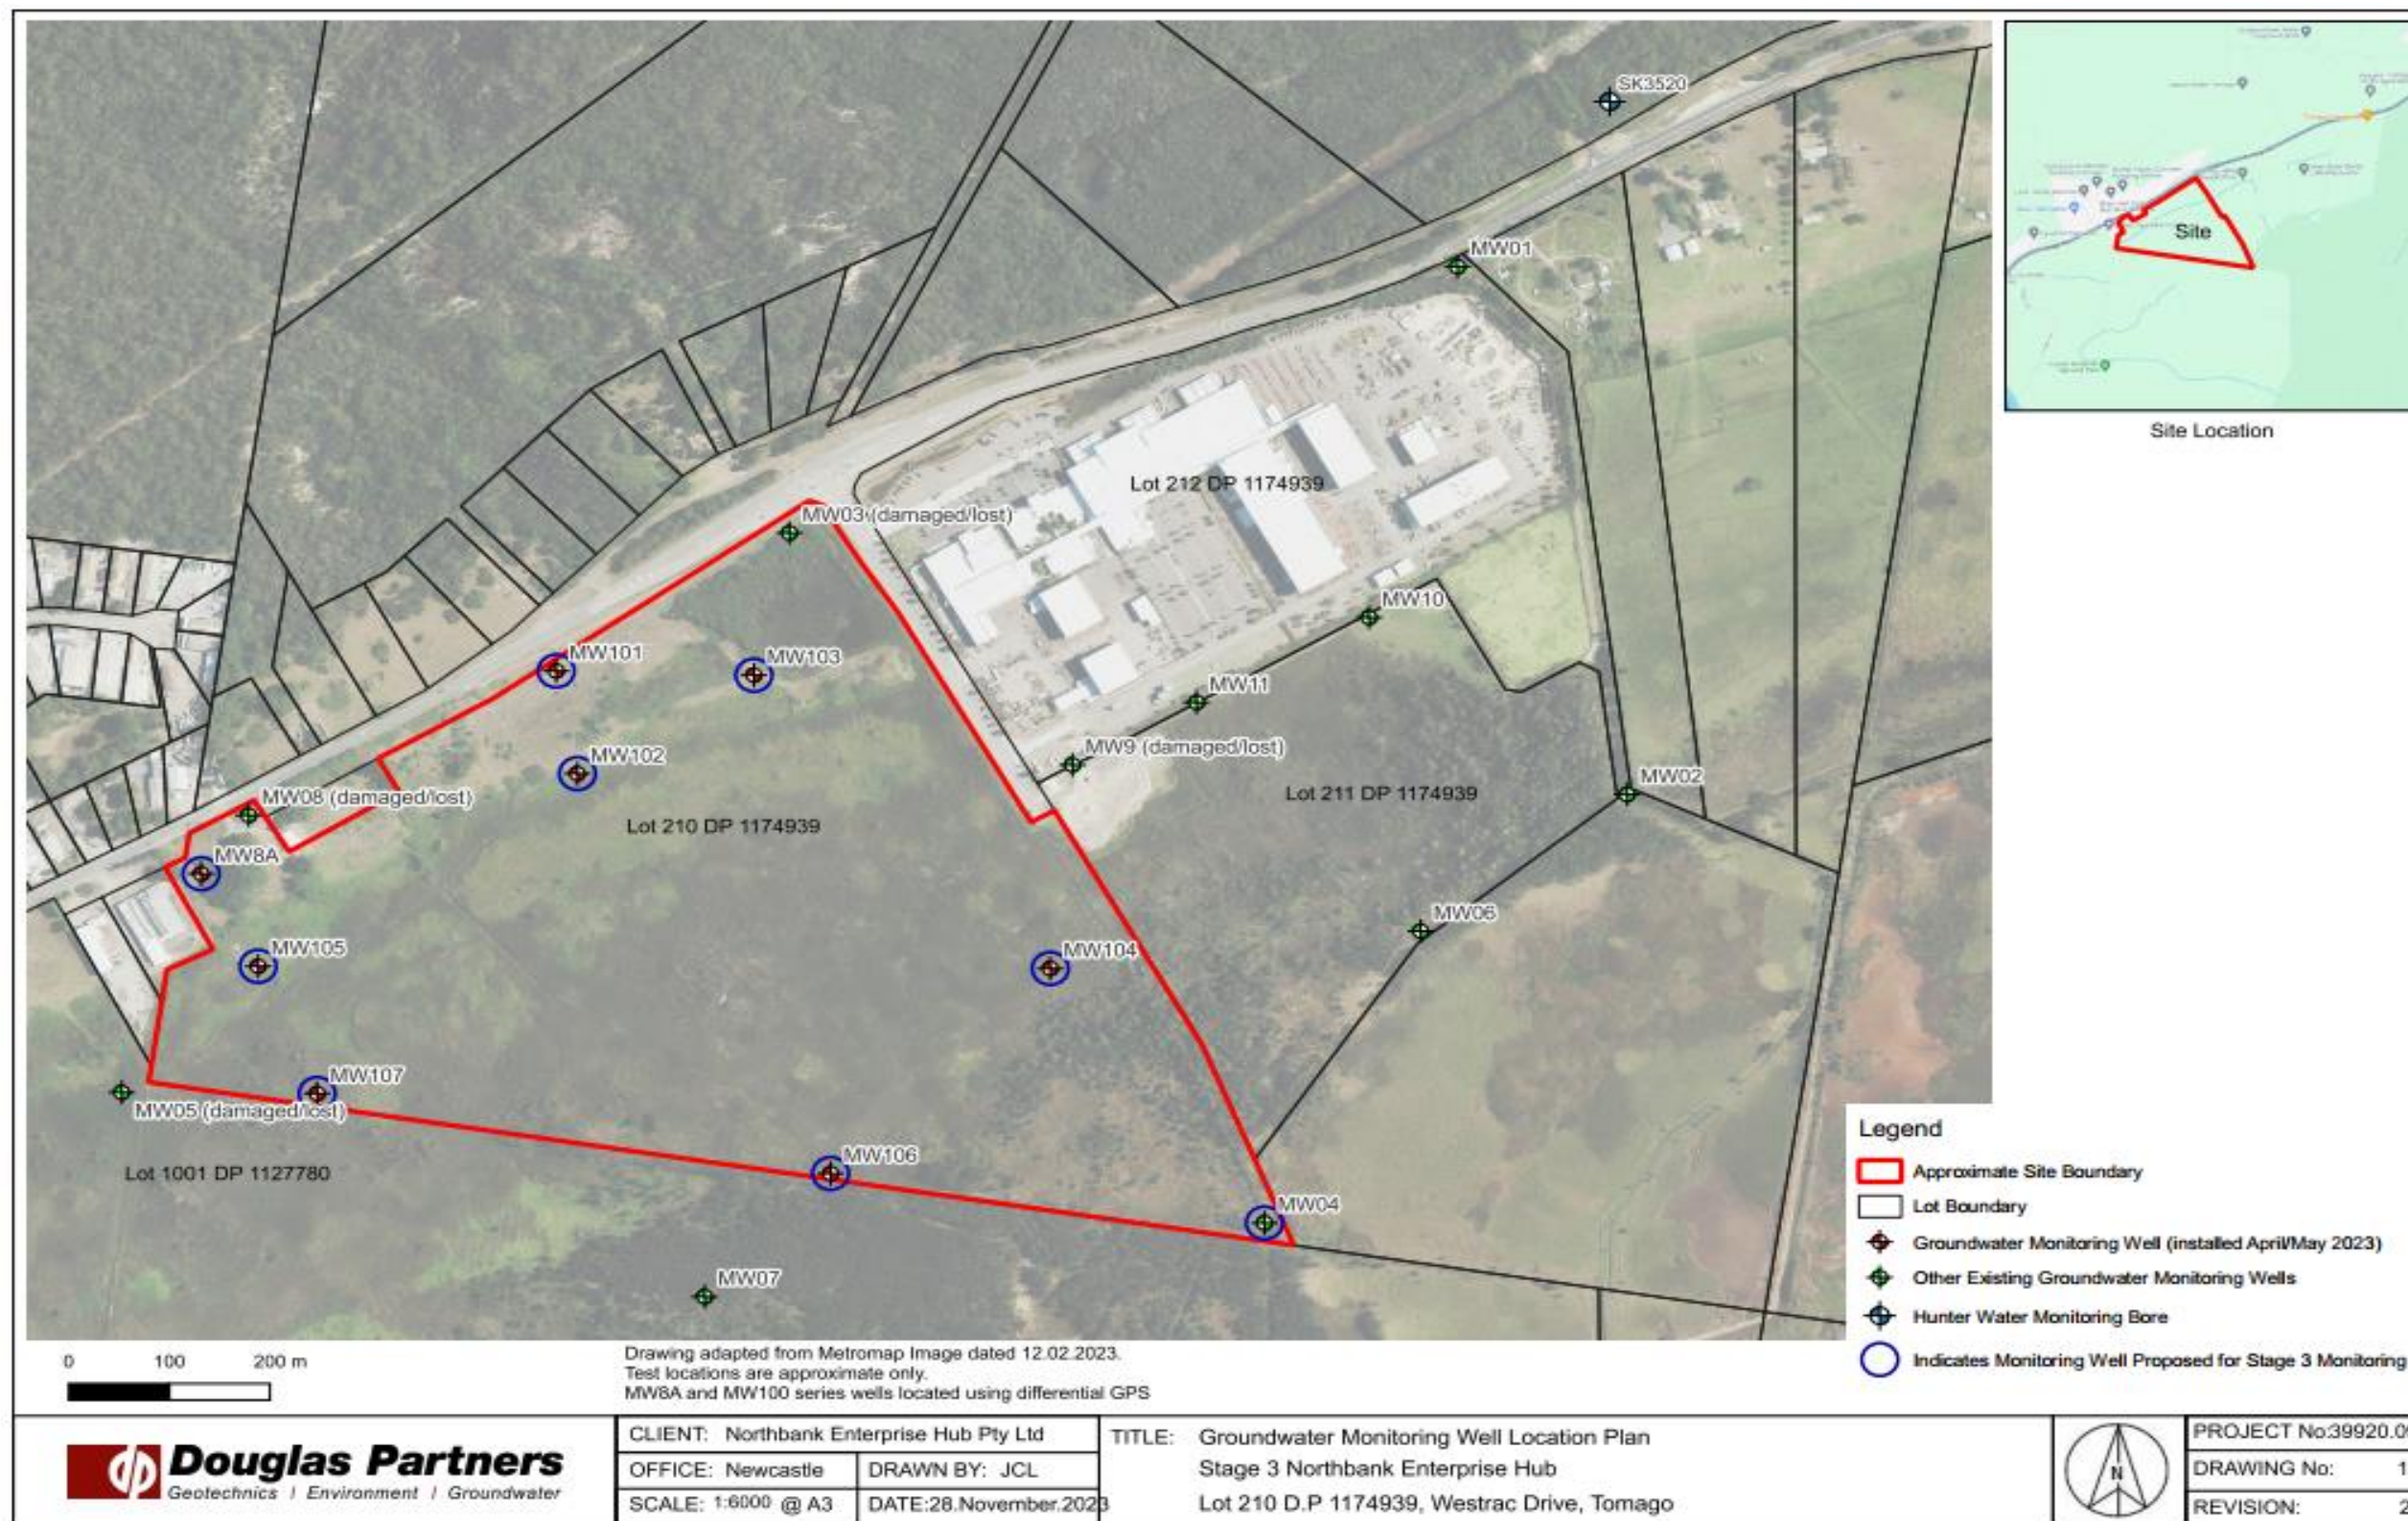
Figure 5: Groundwater monitoring well location plan
