Groundwater Management Plan  
EPBC 2007/3343

Proposed Industrial Subdivision  
Stage 3, Lot 210 D.P.1174939, 2 Westrac Drive, Tomago

Prepared for  
Northbank Enterprise Hub Pty Ltd  
in consultation with  
Torque Projects Pty Ltd

Project 39920.09  
April 2024

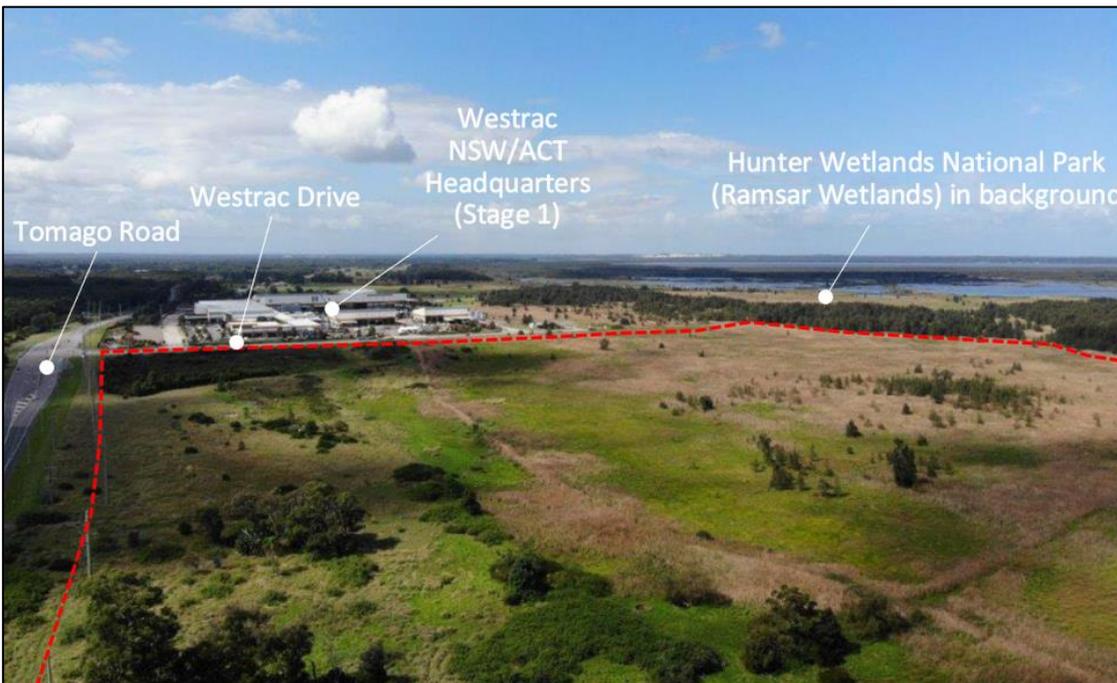
Figure 2: Approximate Lot 210/Stage 3 boundary shown in red. Westrac NSW/ACT Headquarters (Stage 1) in background (Image Adapted from Torque Projects)

- Assessment of water level data at MW04 and the downstream data provided by NPWS to establish baseline water level trends.
  - Monitoring of observation areas to establish baseline site conditions (refer to Figure 2 on Page 5 for potential observation areas).

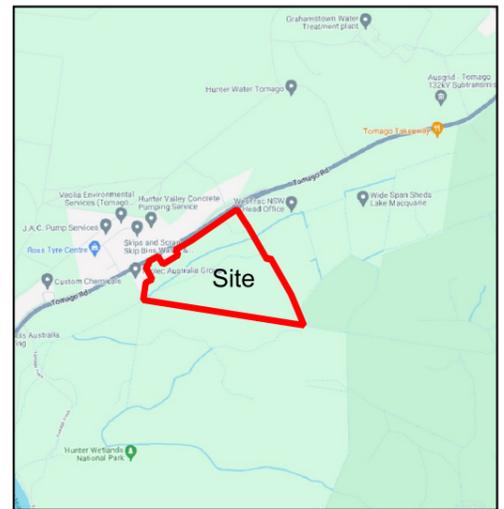
Figure 4.1 - Proposed development site layout, bulk earthworks plan, developed catchments and drainage configuration

As detailed in the SWMP, the proposed stormwater management measures have been designed to collect site-based surface water runoff as well as surface water drainage flows inflows from upstream areas of the catchment at Tomago Road. The surface water drainage configuration is shown in Figure 4 based on WRM Figure 4.1 from the SWMP (WRM, 2024) and includes the following:

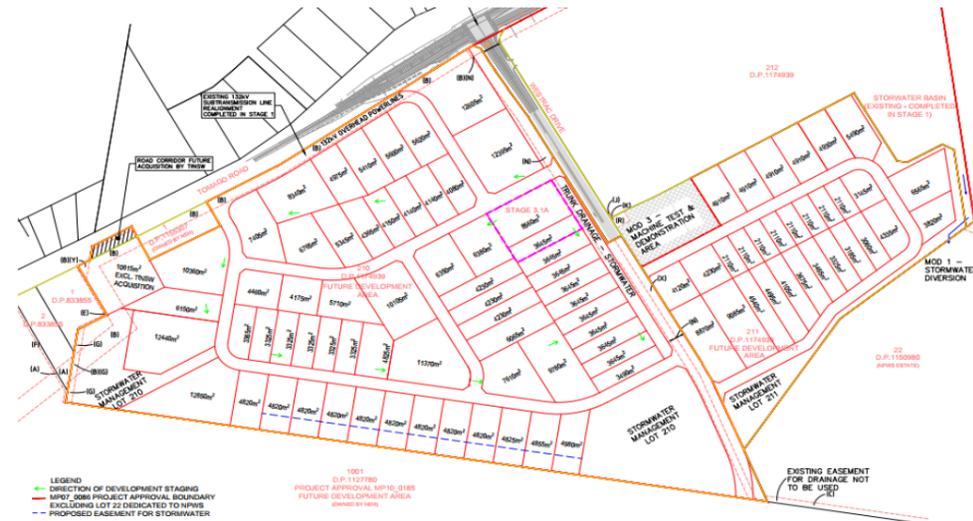
Estate Layout Plan

Figure 1: Drain clearing plan (for TARP#1 on Page 1)

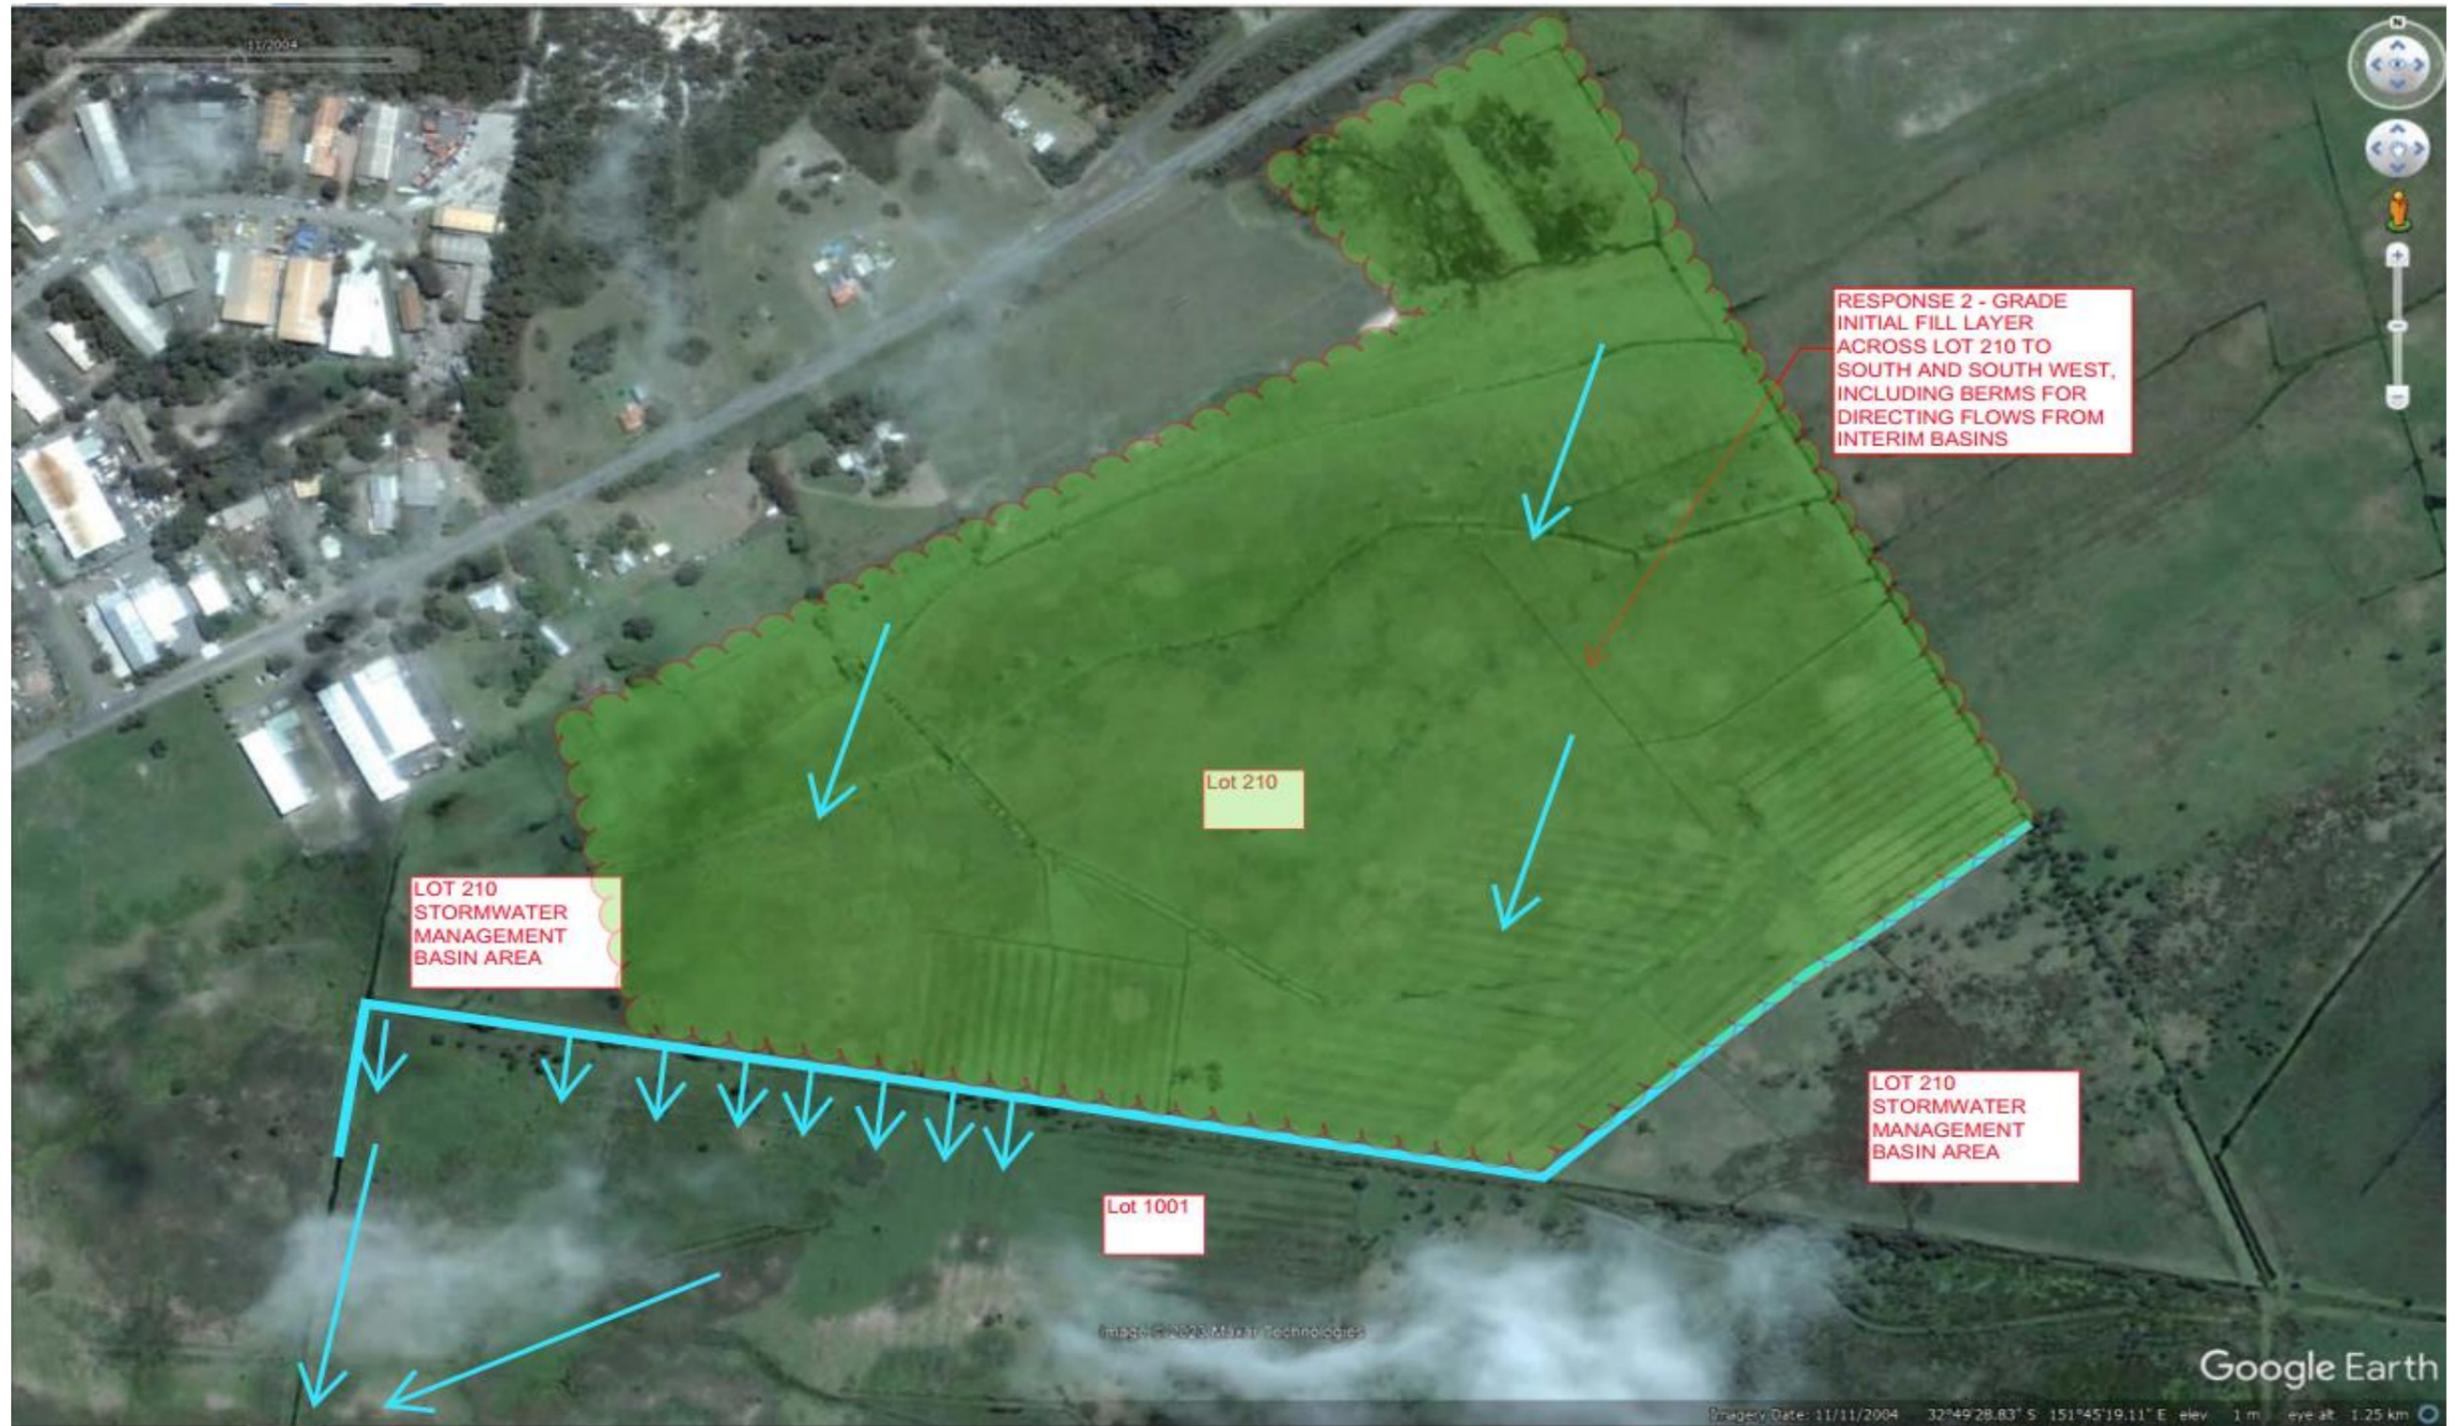
Figure 3: Response 2 (for TARP#1 on Page 1) - Extent of proposed initial fill layer, graded towards the south and southwestern boundaries of Lot 210
