**Groundwater Monitoring and
Management Plan
Revision 3**

**Stage 1 Northbank Enterprise Hub
(EPBC Approval 2007/3343)**

**Lot 212 and Part Lot 211 DP 1174939,
Westrac Drive, Tomago, NSW**

**Prepared for Northbank Enterprise Hub
Pty Ltd**

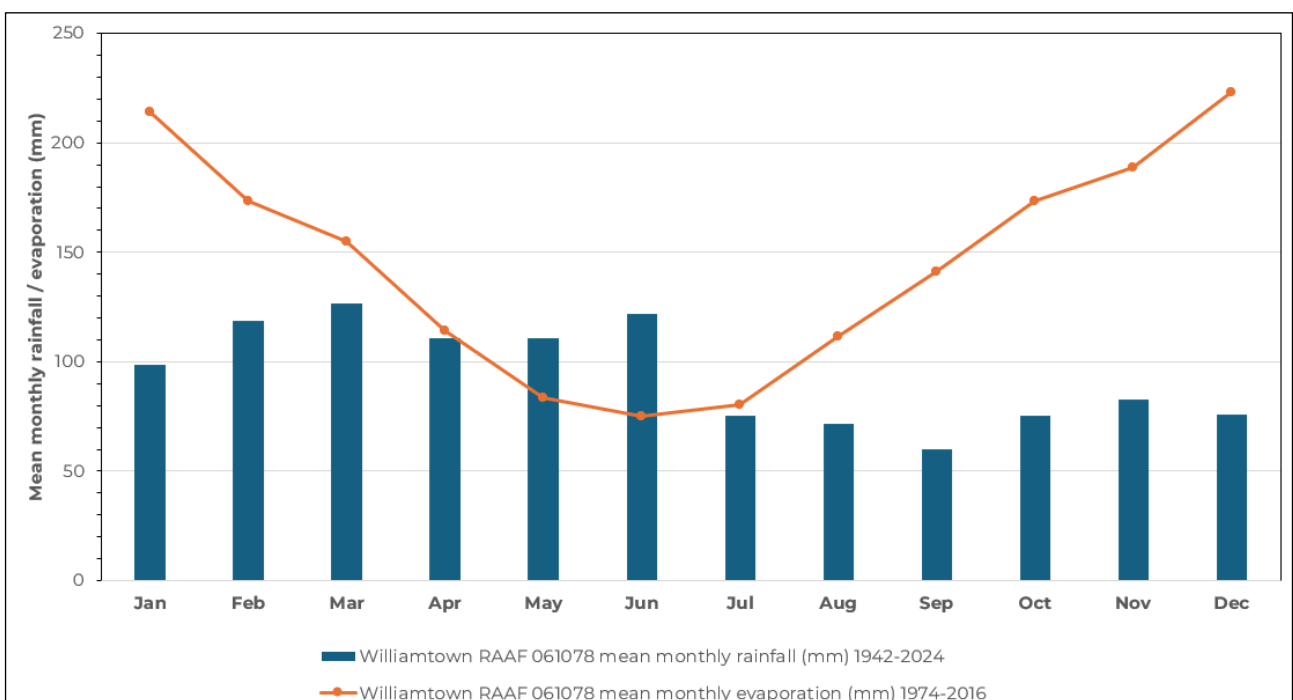
The highest rainfall typically occurs in March (126.9 mm on average) and the lowest in September (60.2 mm on average). Figure 3 compares the available mean monthly rainfall to the evaporation data. Evaporation exceeds rainfall for most months, except May and June.

Figure 3: Mean monthly rainfall and evaporation

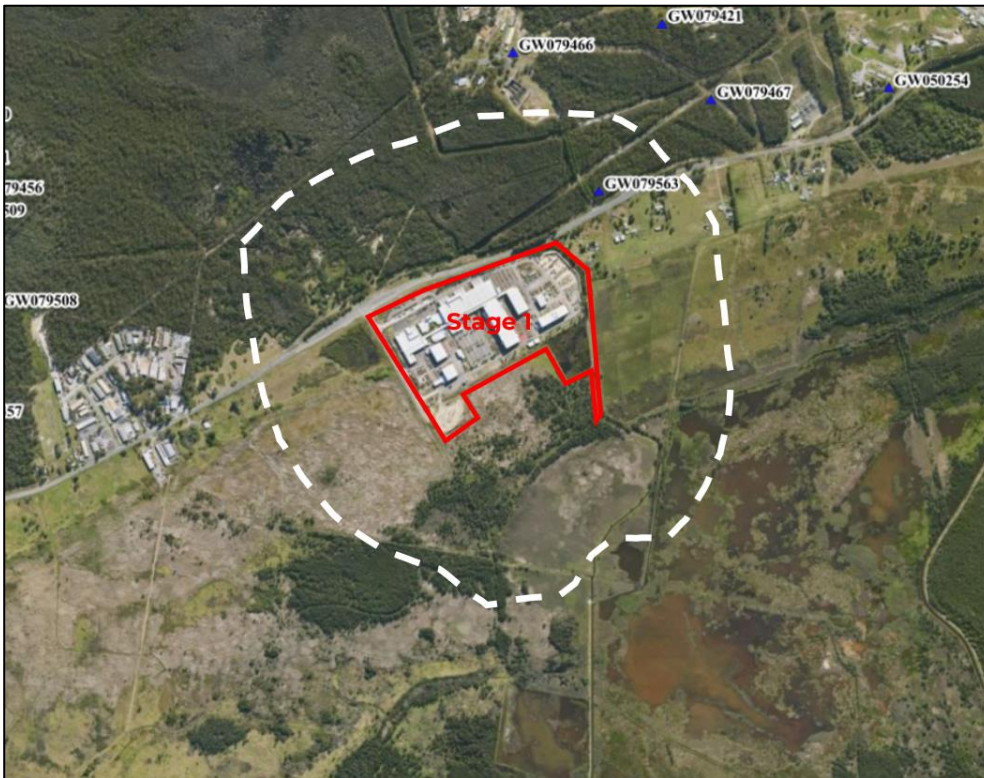
A search of the publicly available registered groundwater bore database indicates there is only one registered groundwater bore within 500 m of the site as shown in Figure 5. It is noted that the published records provided limited information only which is summarised in Table 5.

Figure 4: Registered groundwater bores relative to Stage 1 boundary. 500 m buffer shown in white

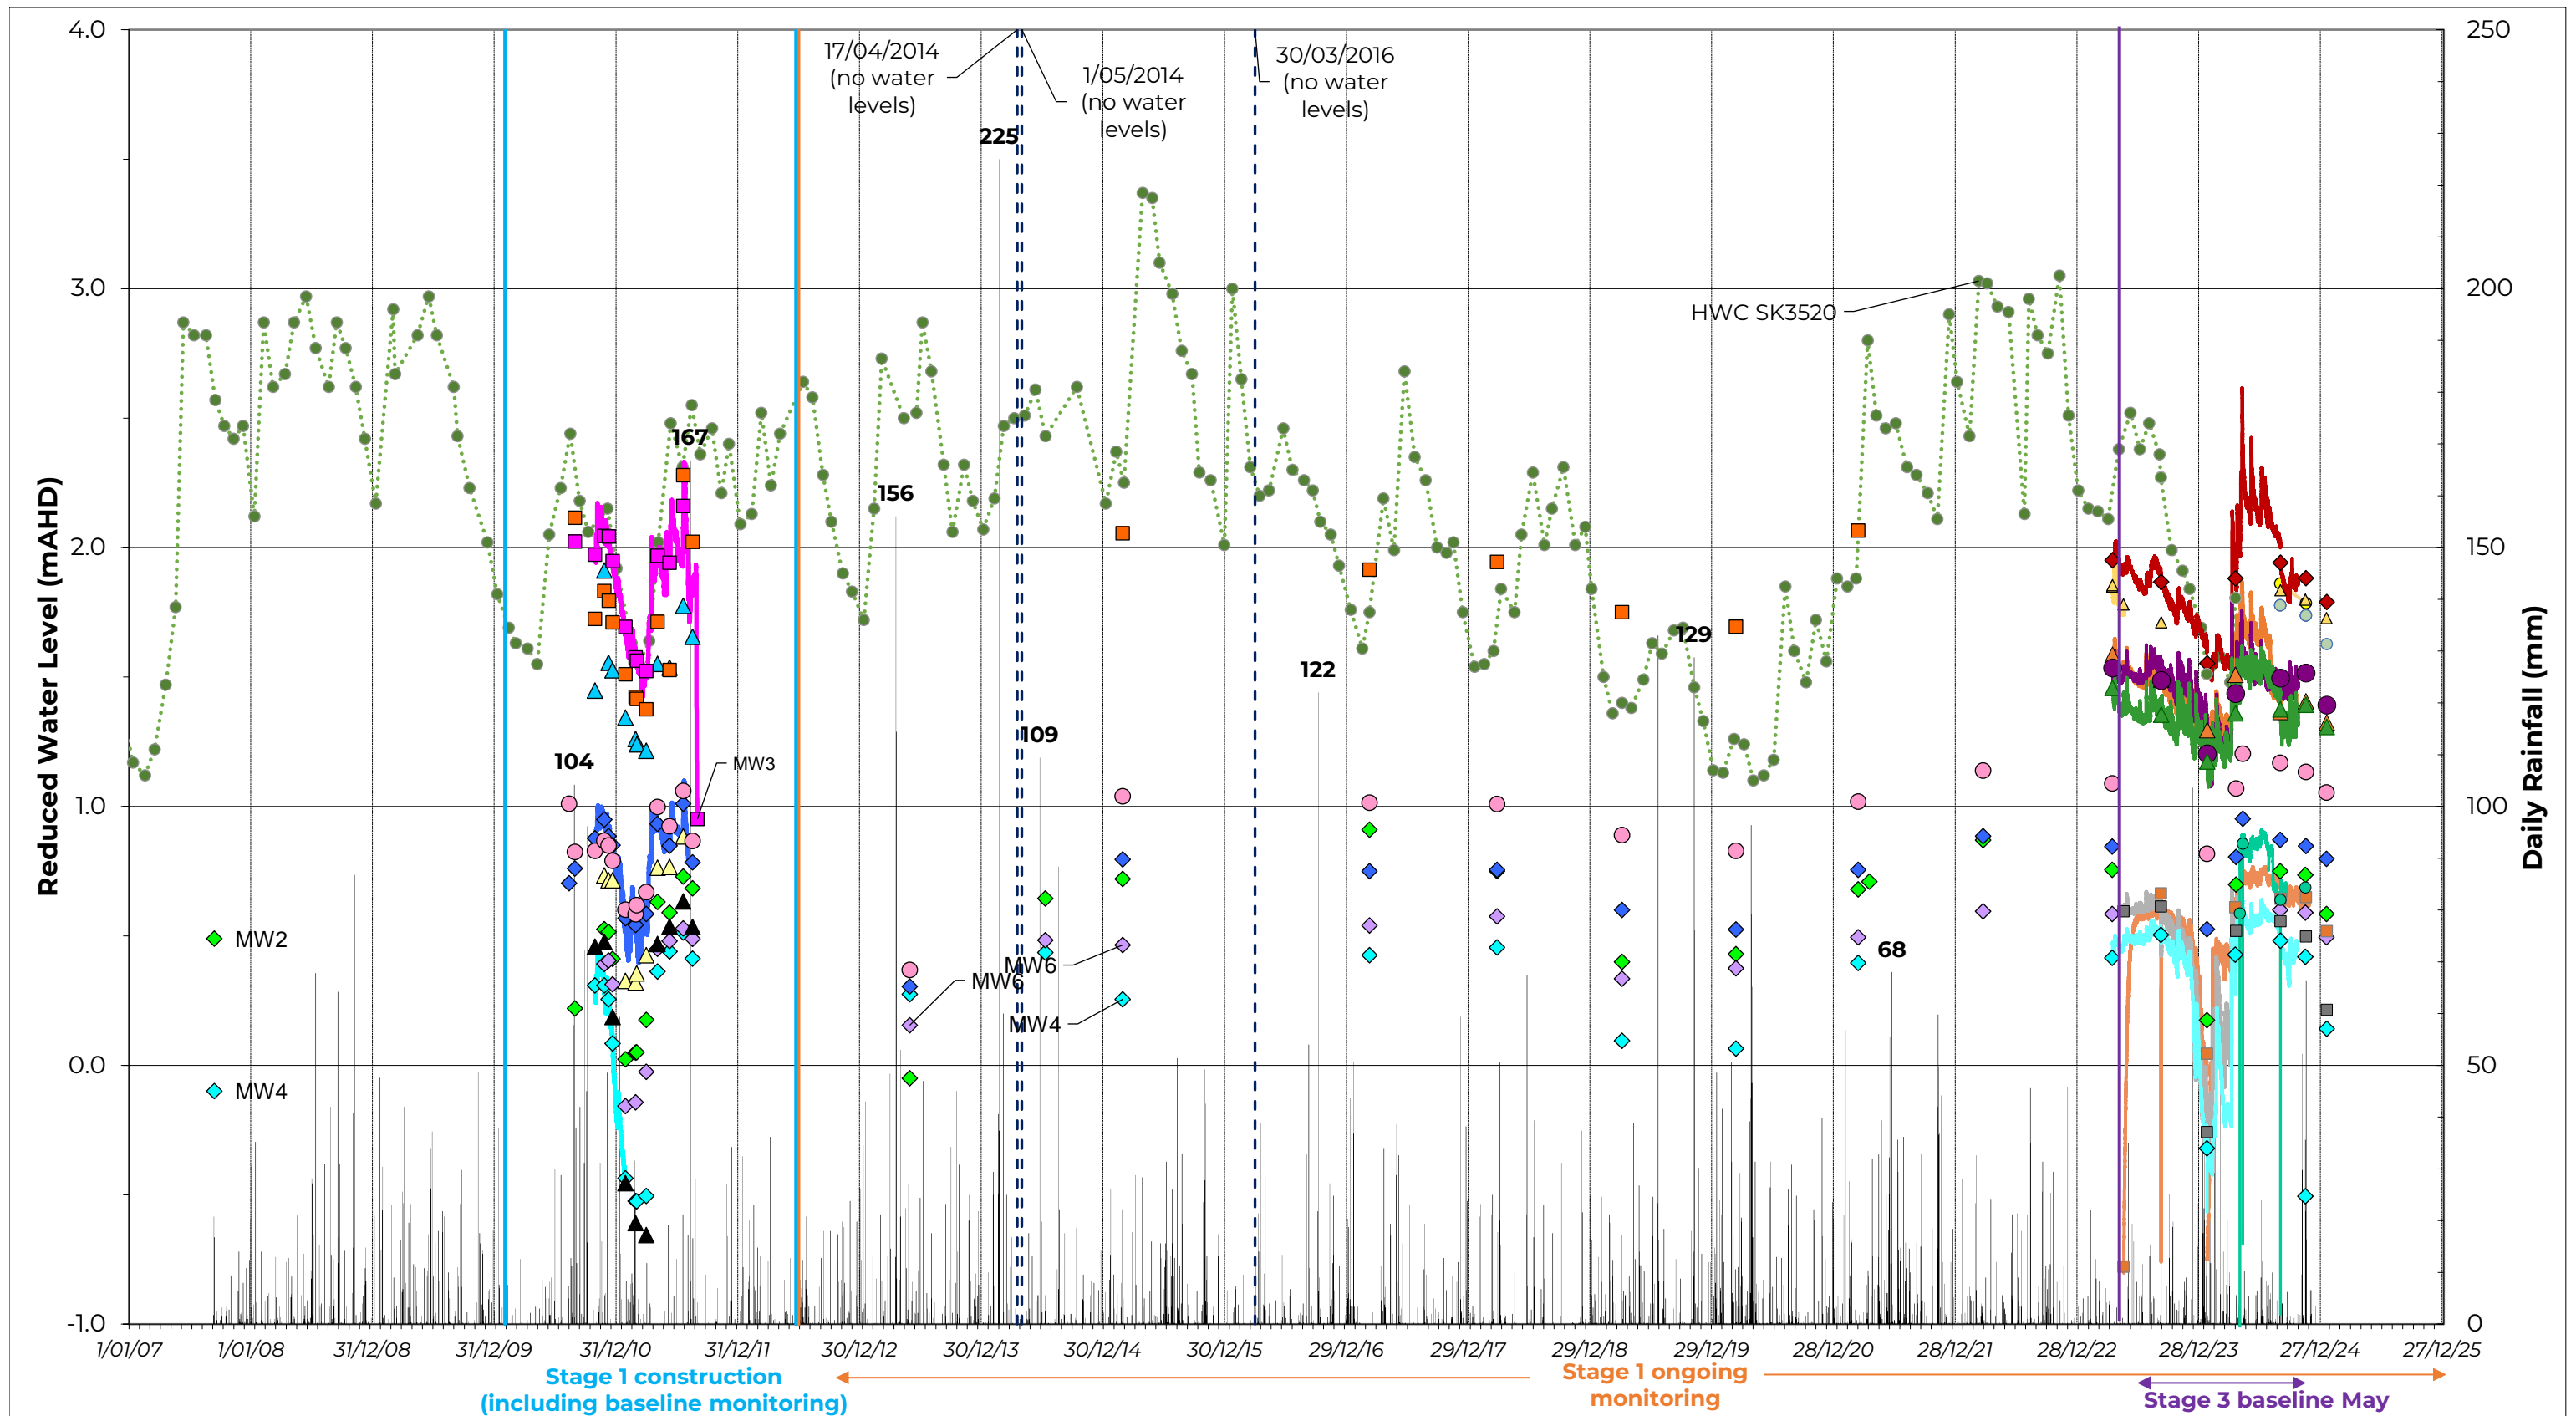
Figure E1: Groundwater Levels in Monitoring Wells (2007-2025)

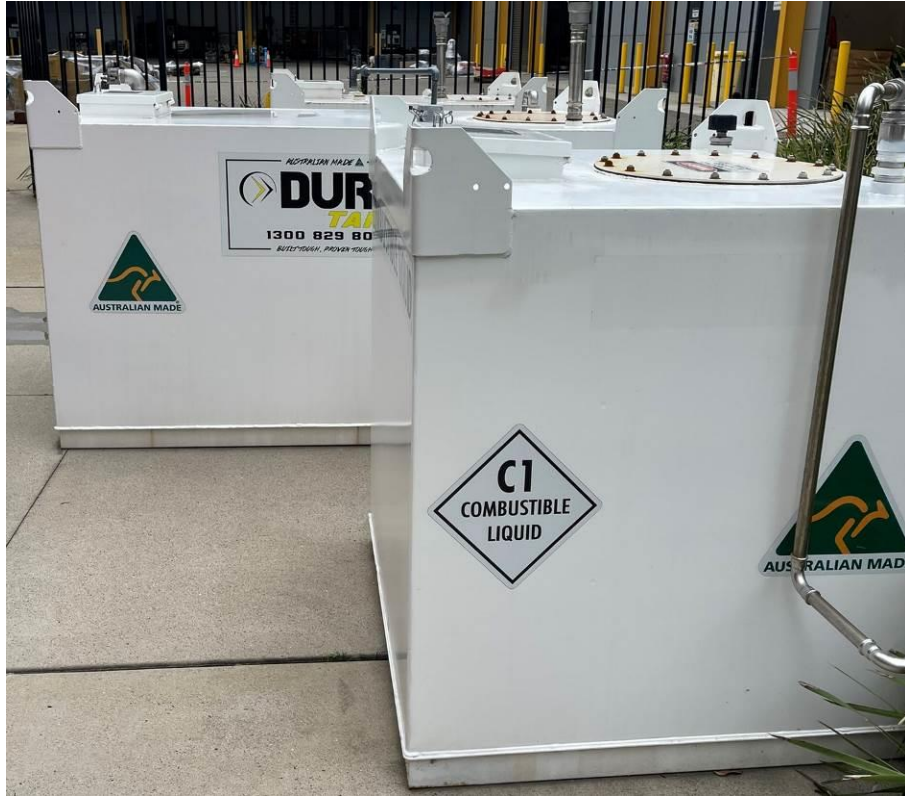
Photo 1: Self bunded coolant (1000 L)

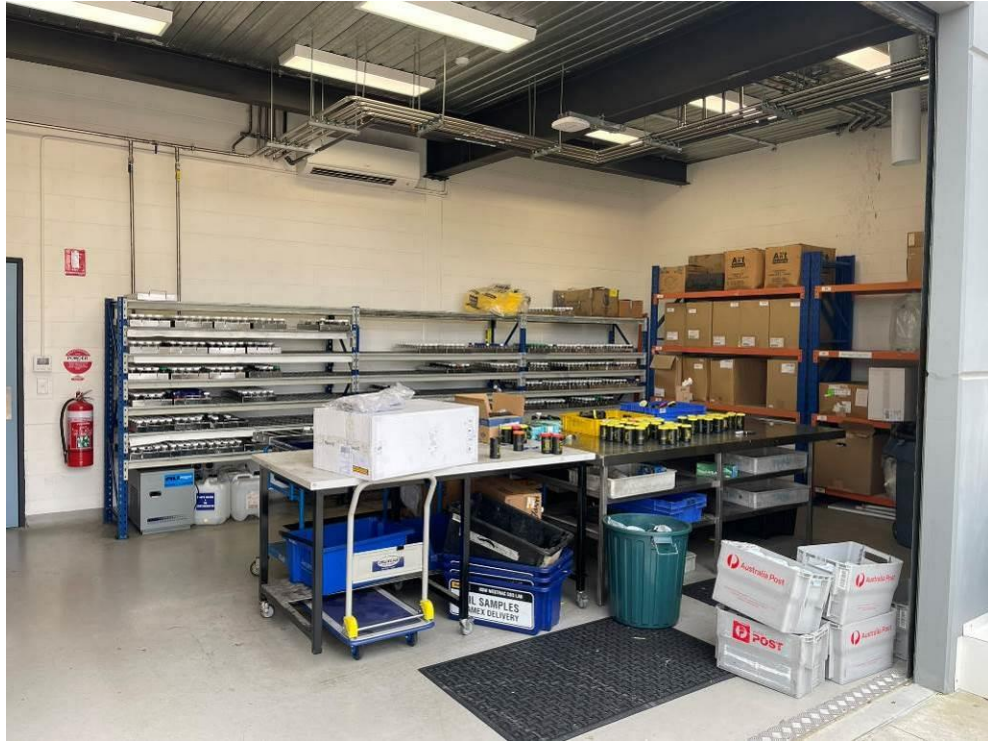
Photo 3: Hydraulics sampling - building A

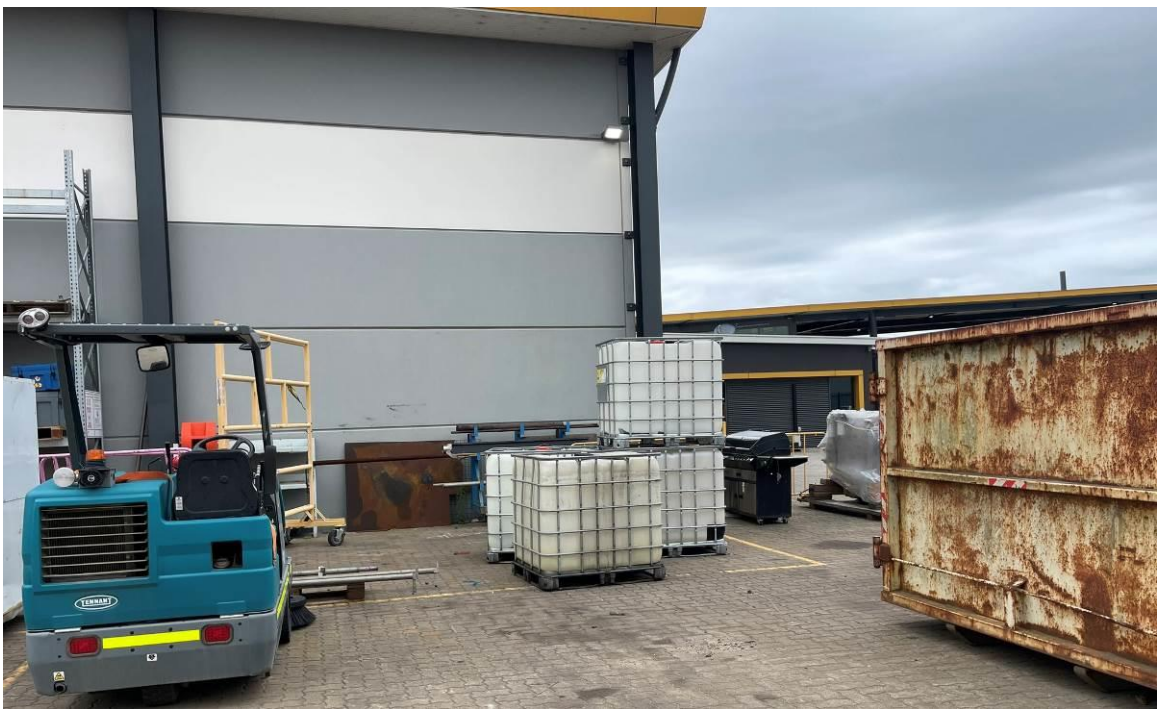
Photo 6: Empty intermediate bulk storage containers

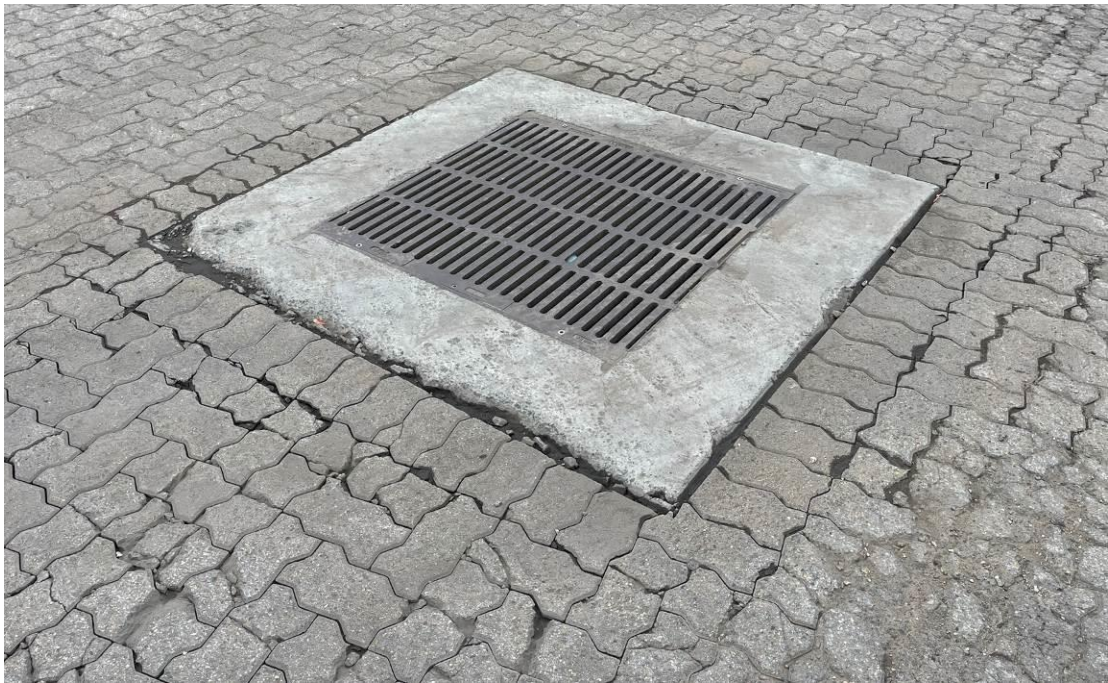
Photo 8: Drains within paved areas

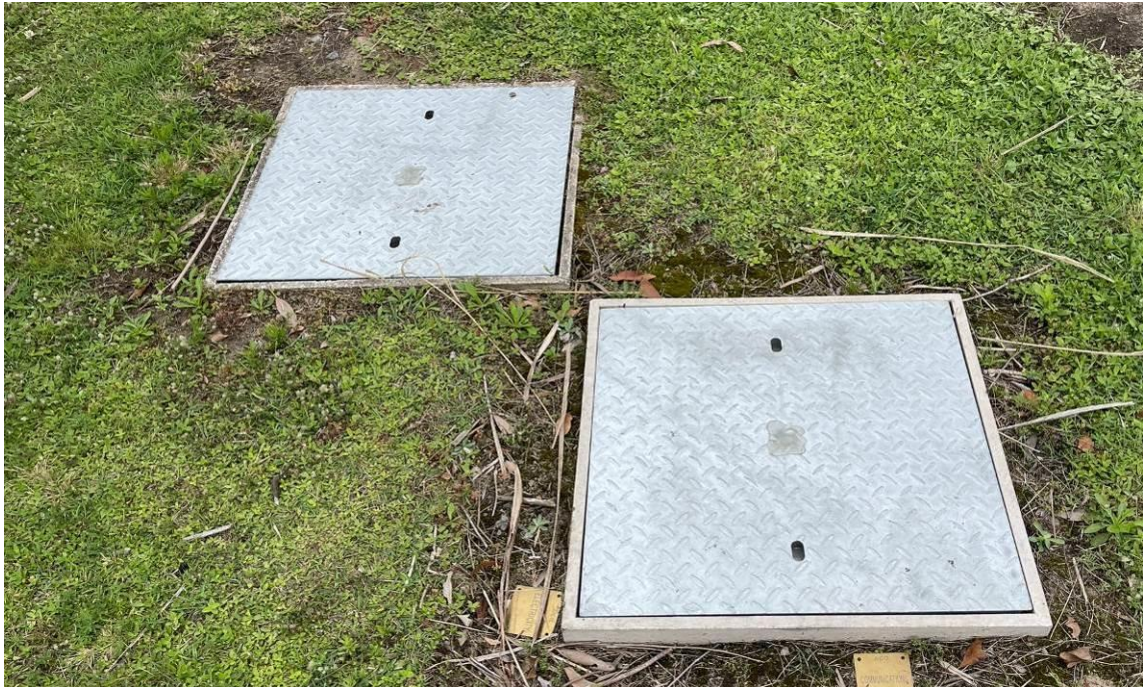
Photo 12: Service inspection pits

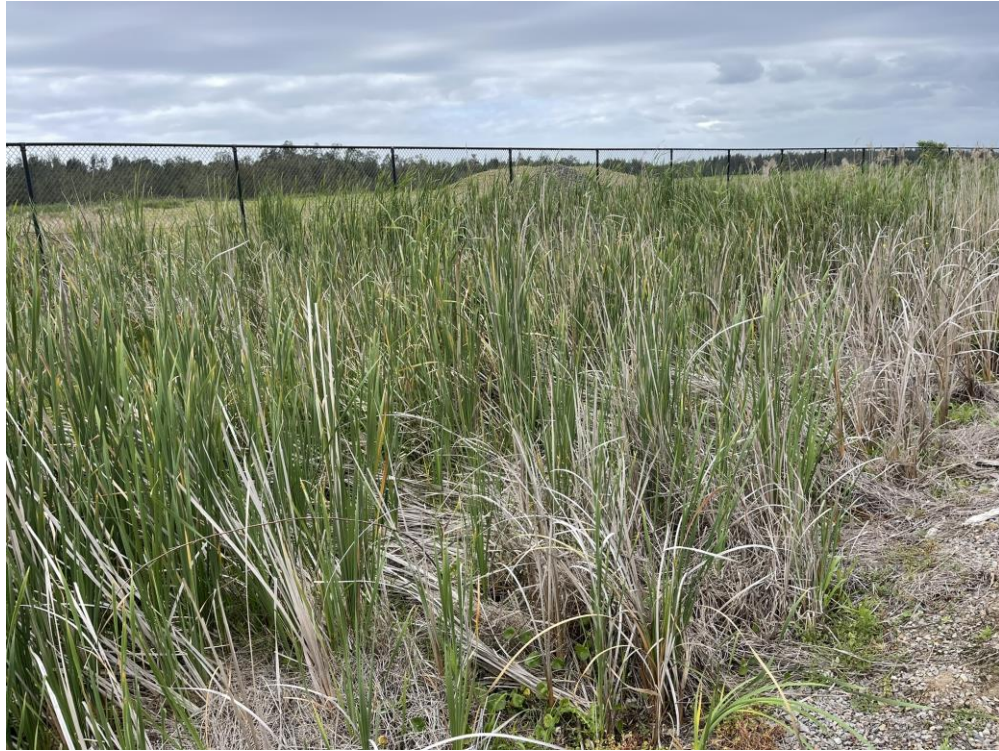
Photo 13: Southern swale and reed vegetation.

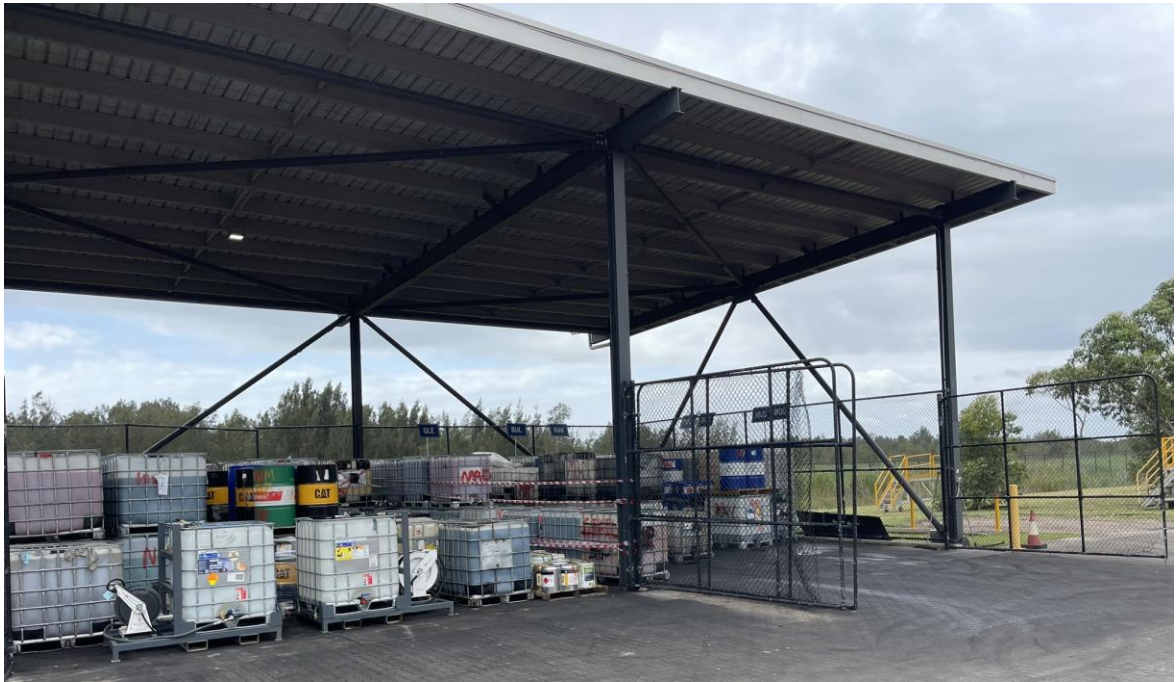
Photo 15: Bulk oil storage within bunded waste depot

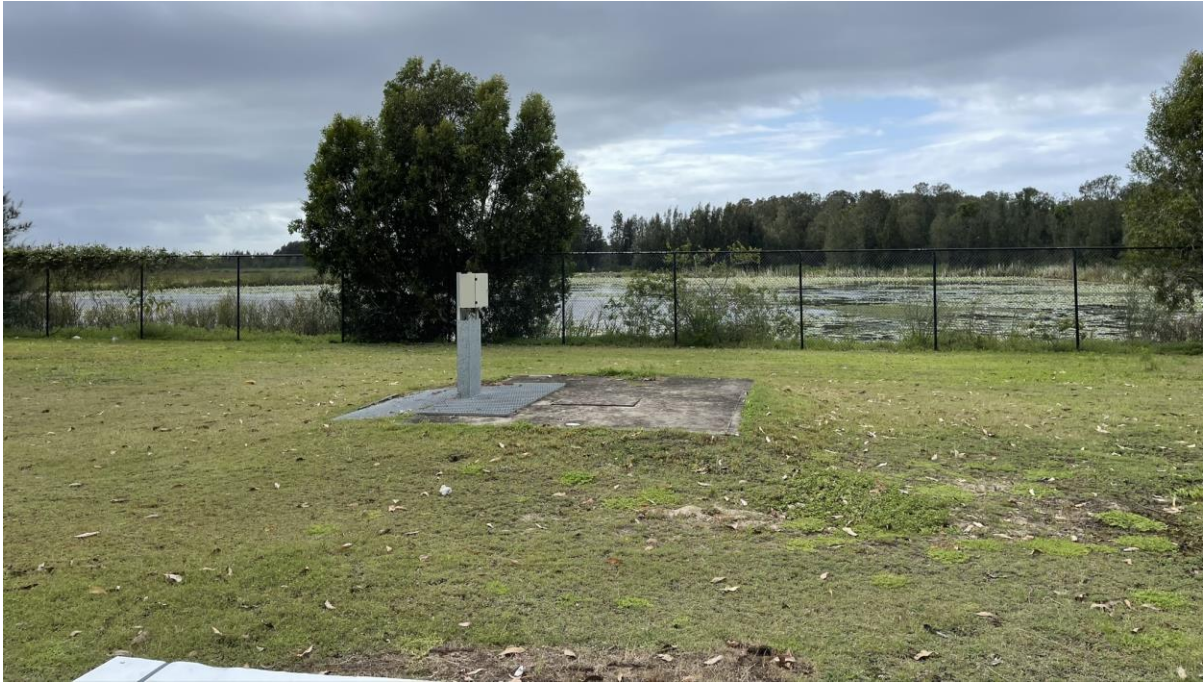
Photo 17 Sewer pump station and Basin 1 in background
